Lower Kishacoquillas Creek Watershed Assessment

Mifflin County Conservation District
20 Windmill Hill #4
Burnham, PA 17009

November 2005

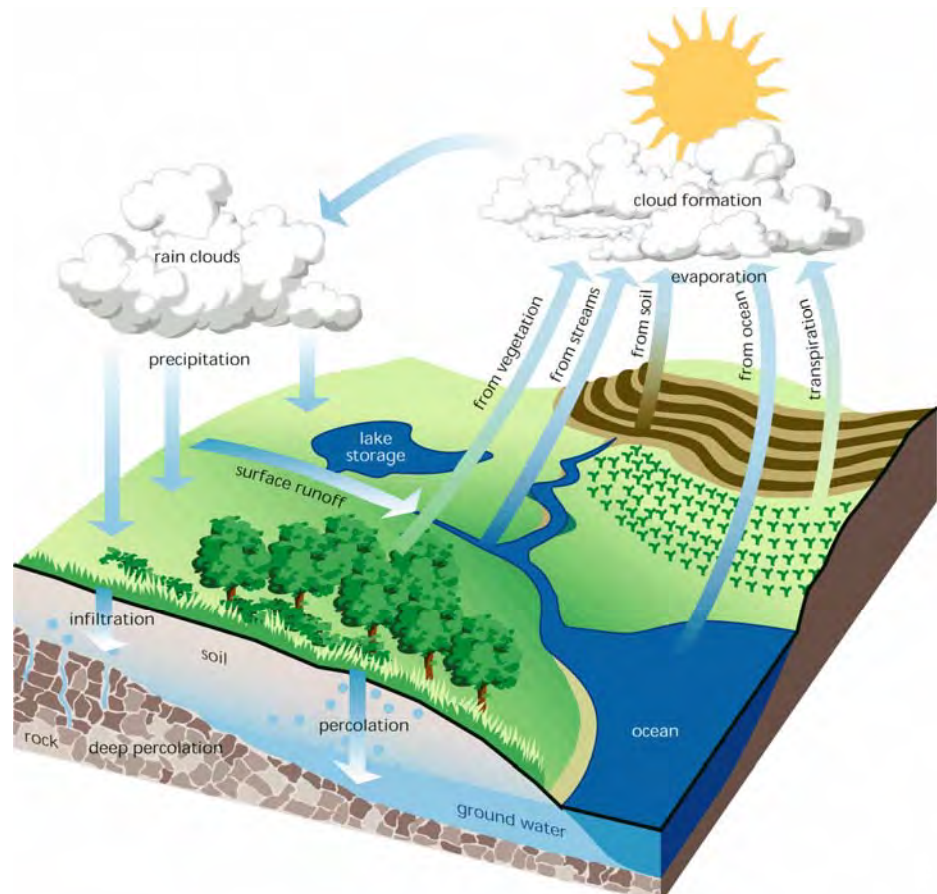
Figure 1.1. The hydrologic cycle. The transfer of water from precipitation to surface water and groundwater, to storage and runoff, and eventually back to the atmosphere is an ongoing cycle (<http://www.cet.nau.edu/Projects/SWRA/research.html>).

The water cycle, also known as the hydrologic cycle, is the process through which water is recycled (Figure 1.1). Water is stored in the atmosphere in the form of clouds and water vapor. The surrounding air temperature determines the state that the water will assume when it falls to the earth as precipitation in the form of rain, snow or ice. Precipitation may be taken up by the roots of plants and released through their leaves through the process of transpiration. Precipitation that is not absorbed by plants may infiltrate the soil to become part of the underground water supply, which is referred to as groundwater.

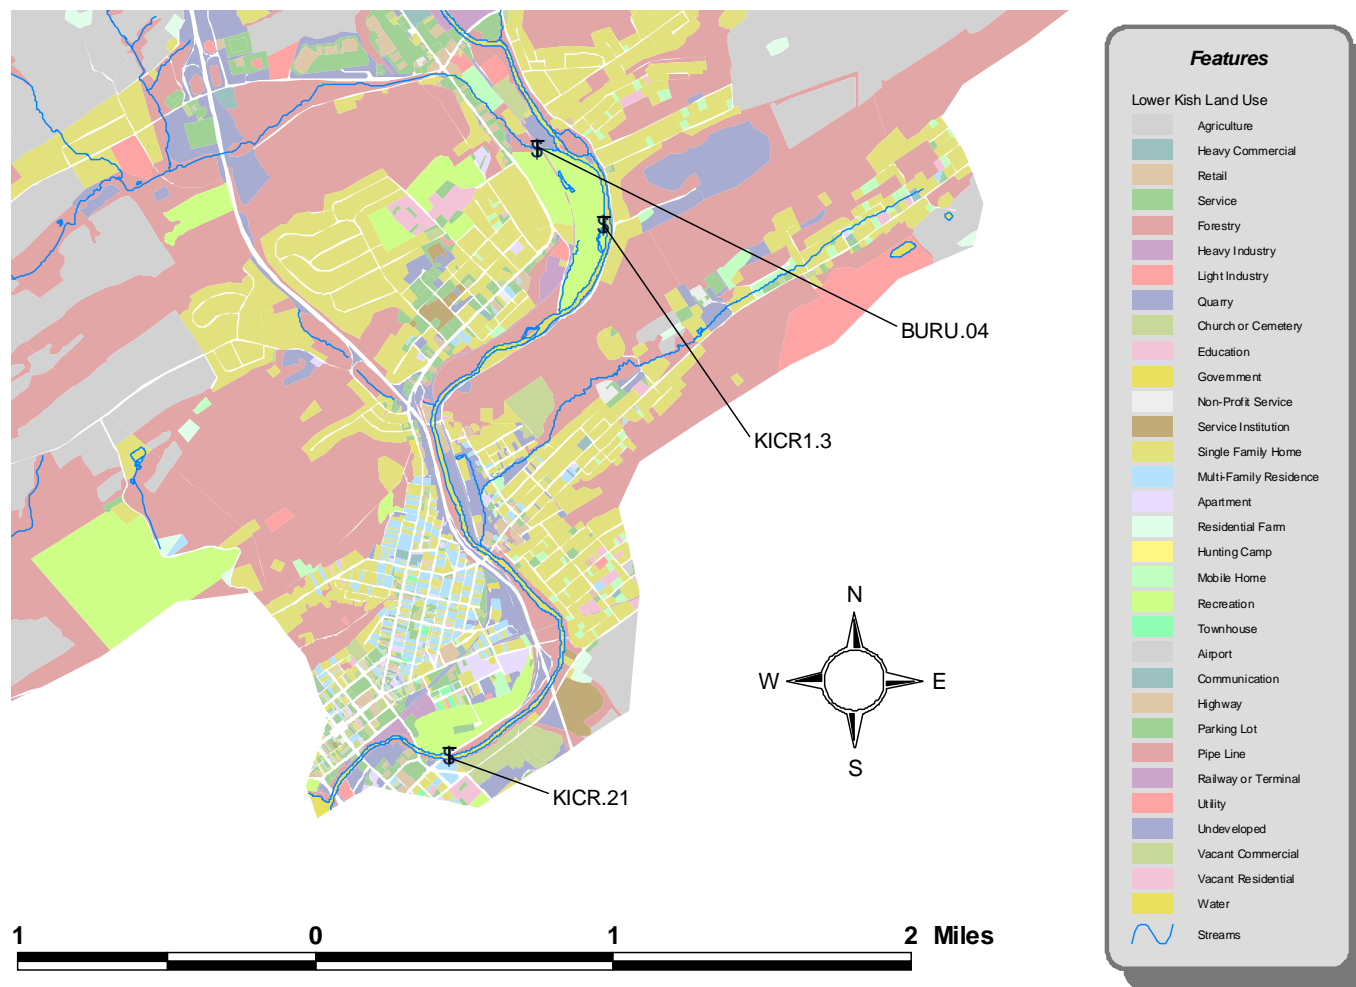
Figure 3.2. Land use patterns in the Lewistown area of the Lower Kishacoquillas Creek watershed.

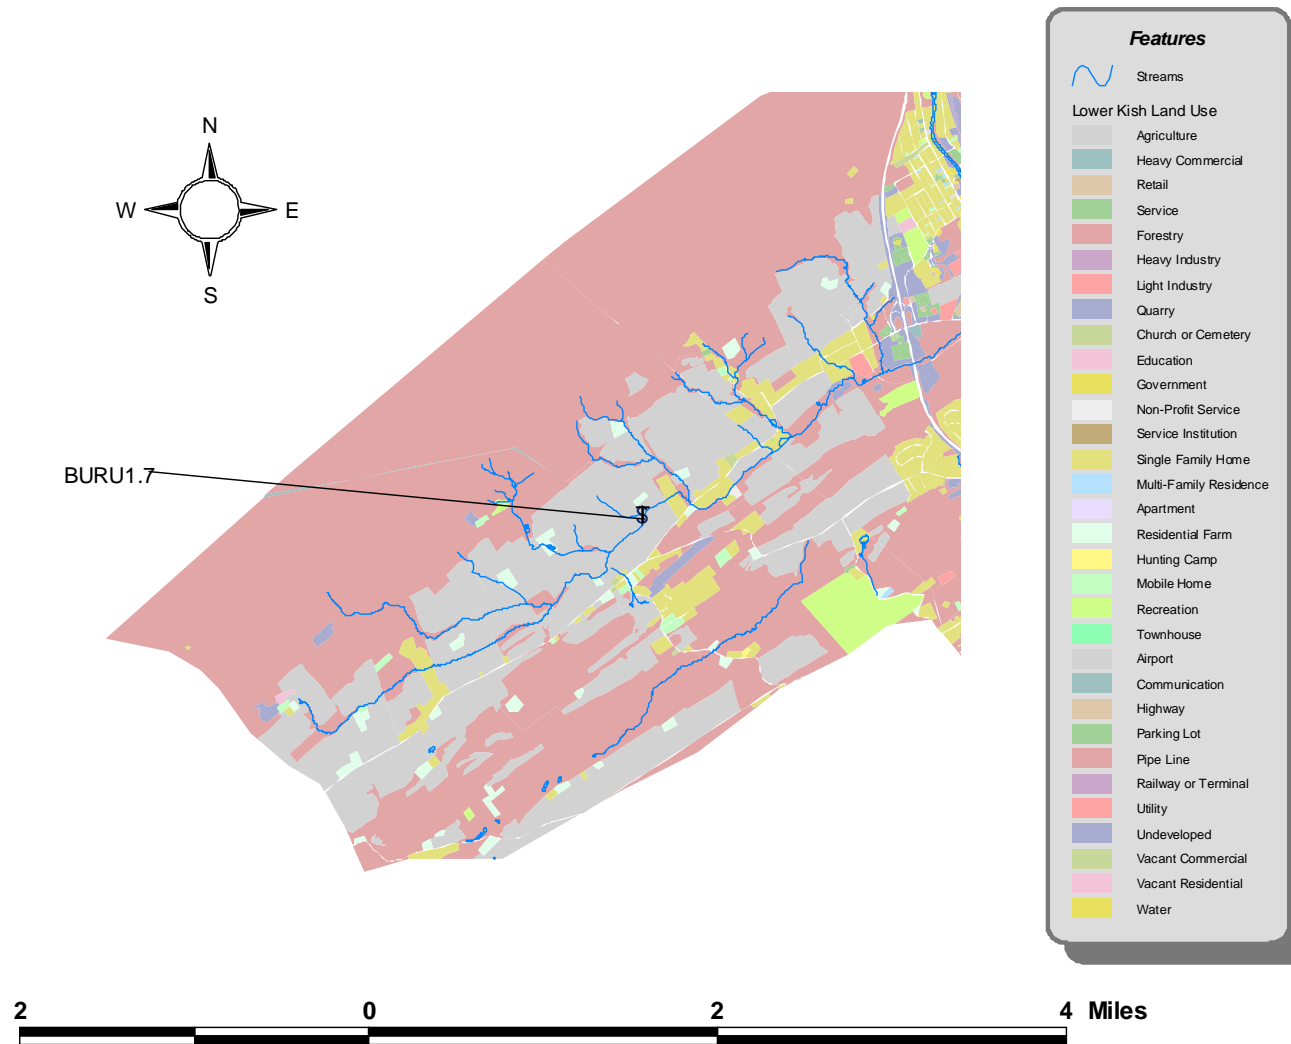
Figure 3.4. Land use patterns in the southwest portion of the Lower Kishacoquillas Creek watershed.

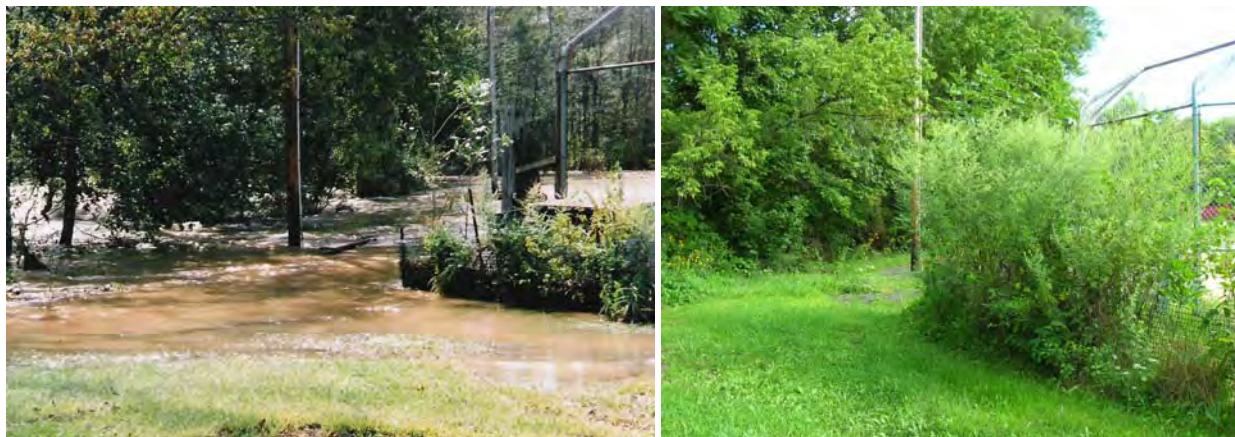
Figure 3.6. Behind the baseball field near Mann's Narrows during the September 2004 flood (left) and during the dry summer of 2005 (right).

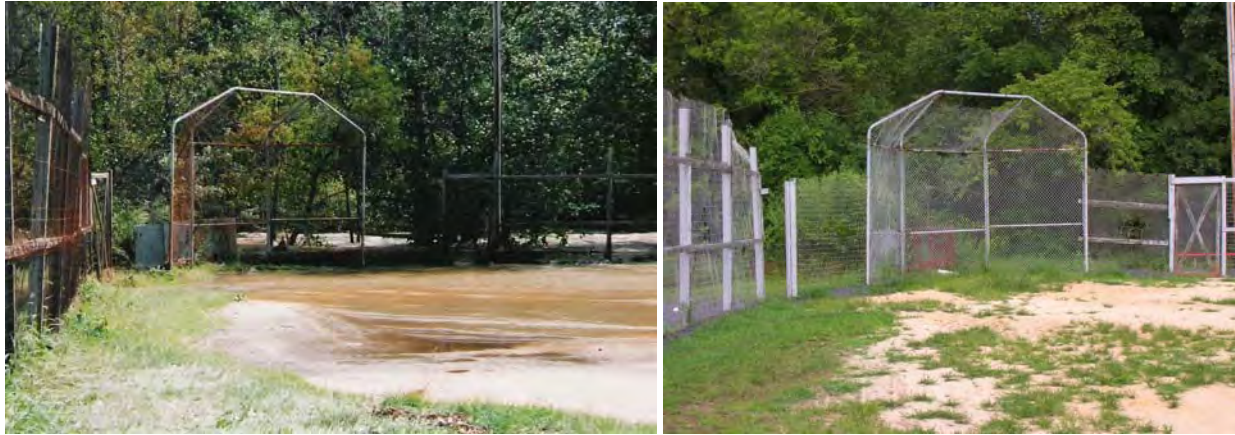
Figure 3.7. Baseball field near Mann's Narrows during the September 2004 flood (left) during the dry summer of 2005 (right).

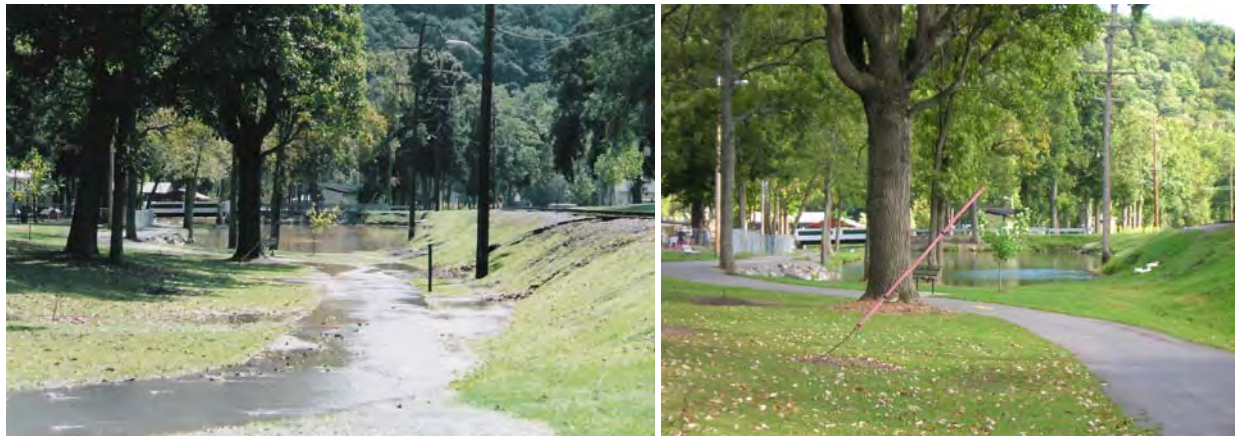
Figure 3.8. The pond in Derry Community Park in Burnham during the flood in September 2004 (left) and during the dry summer of 2005 (right).

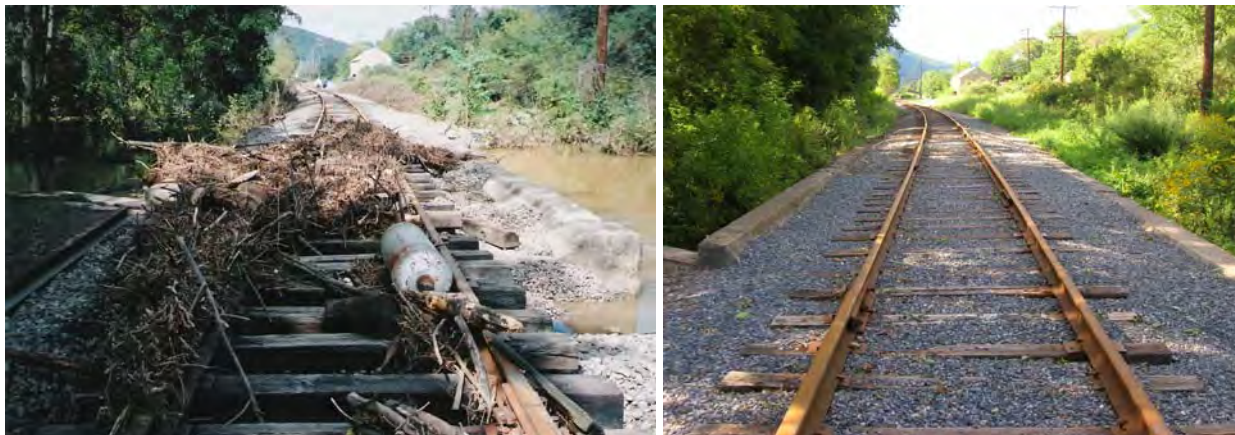
Figure 3.9. The railroad bridge in Derry Community Park in Burnham after the flood in September 2004 (left) and during the dry summer of 2005 (right).

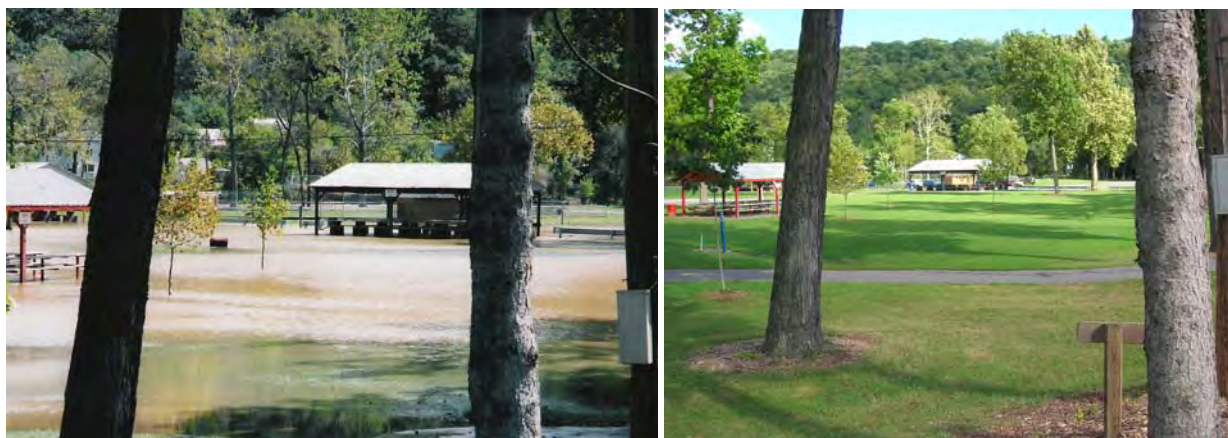
Figure 3.10. Pavilions at Derry Community Park in Burnham during the flood in September 2004 (left) and during the dry summer of 2005 (right).

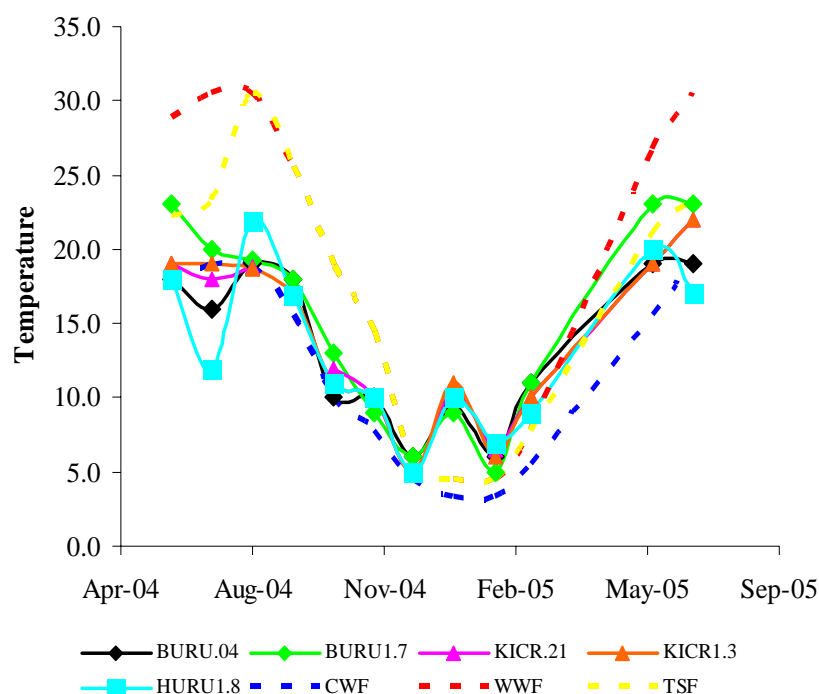
Figure 7.1. Temperature (°C) at each of the five study sites from June 2004 to July 2005, including PADEP maximum temperature standards for CWF, WWF, and TSF.

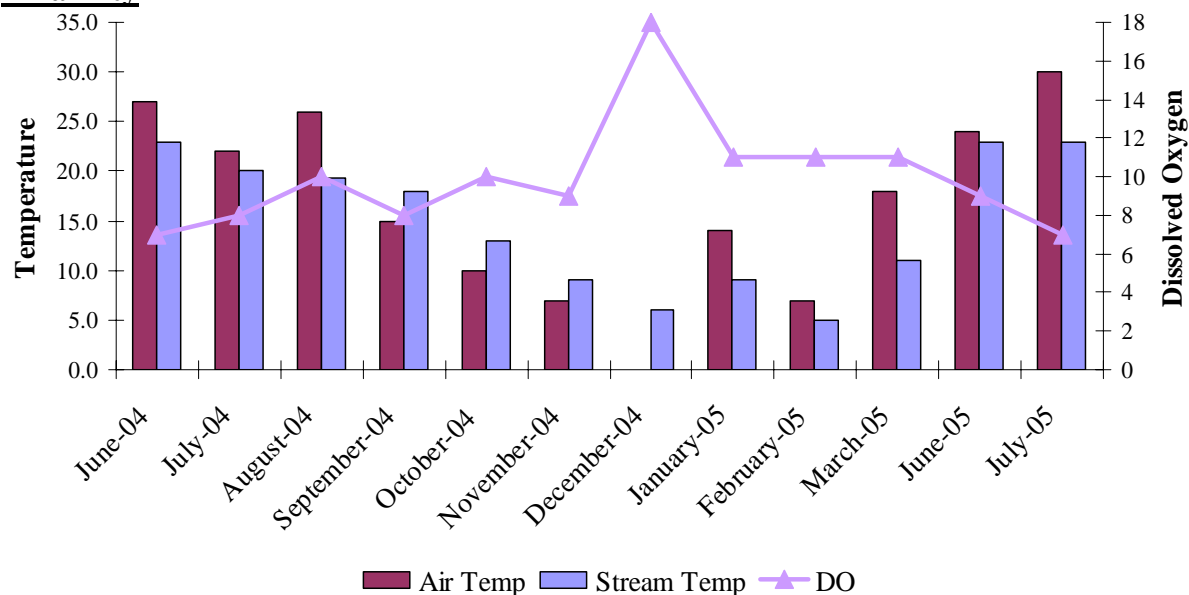
Figure 7.2. Air and stream temperatures versus dissolved oxygen content at BURU1.7 from June 2004 to July 2005.

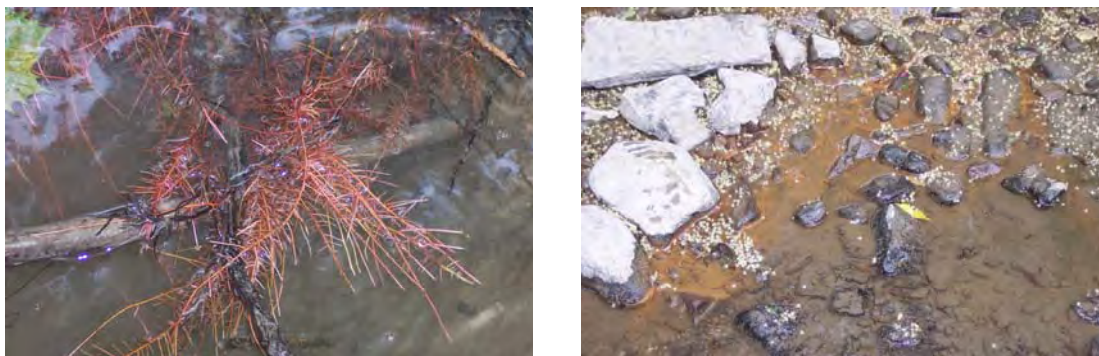
Figure 7.5. Red root hairs (*left*) and rusty sediment (*right*), main stem of Kish Creek in Lewistown, PA.

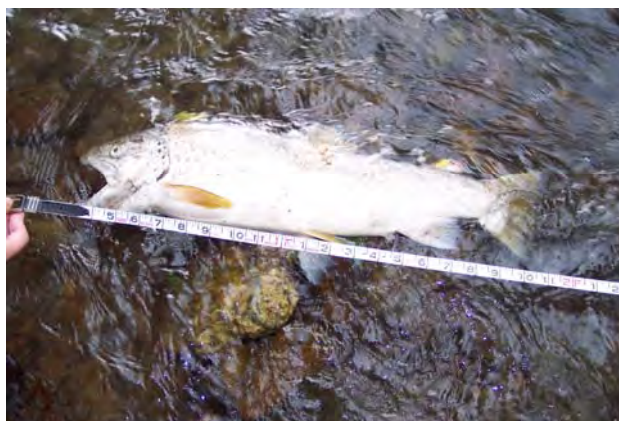
We observed several dead regulation-size brown trout during our visual assessment of habitat along the main stem of Kish Creek. One of these many trout was located within the boundaries of the HQ-CWF area. It is possible that other factors such as hooking stress, or percent saturated oxygen, contributed to the mortality of these large trout, but high stream temperatures recorded during the summer of 2005 may have had a big impact.

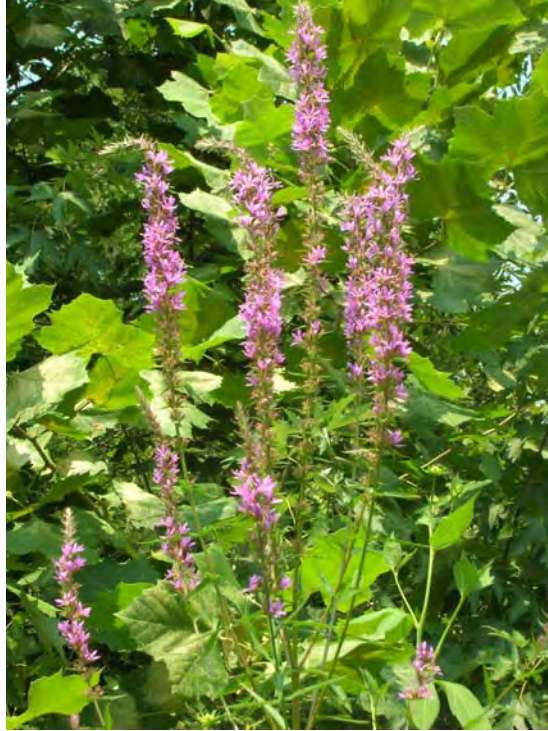
Figure 8.1. Purple loosestrife growing on the bank of Kish Creek at Derry Community Park in Burnham, PA.

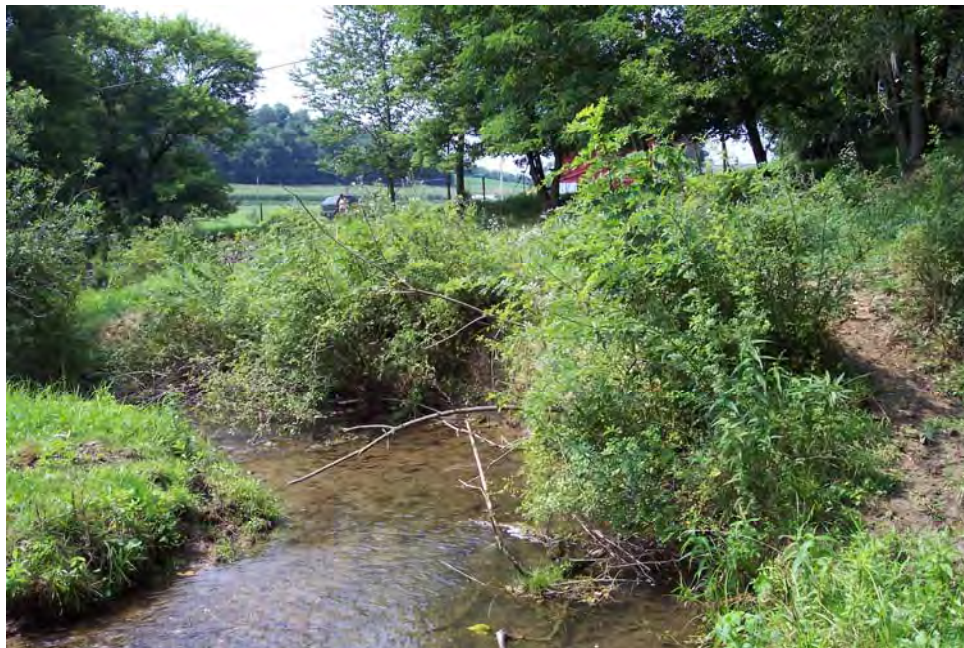
Figure 8.2. Multiflora rose (*right*) growing along the bank of Hungry Run at the study site HURU1.8.

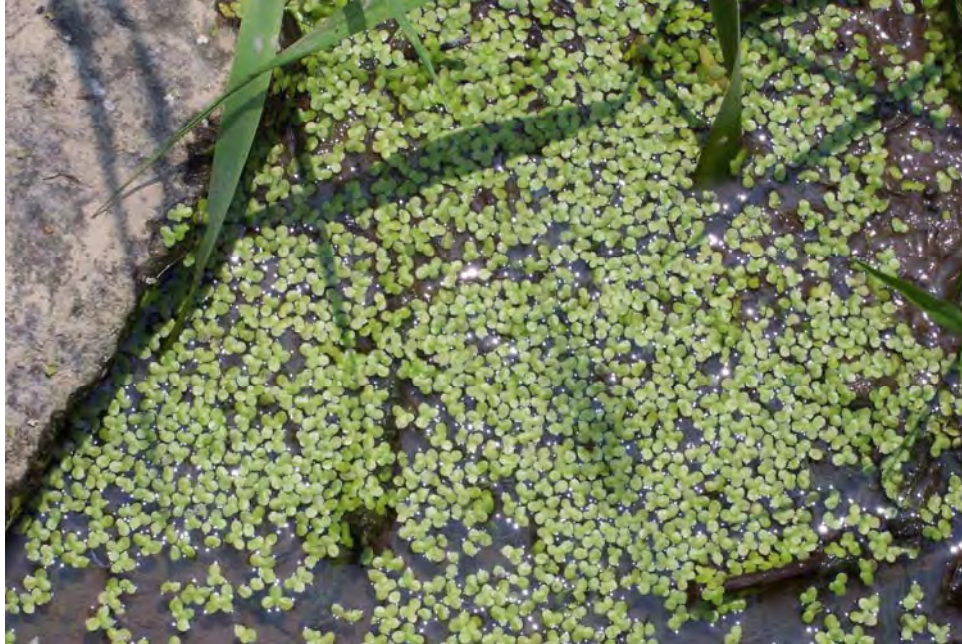
Figure 8.3. Duckweed growing in Kish Creek near Mann's Narrows.

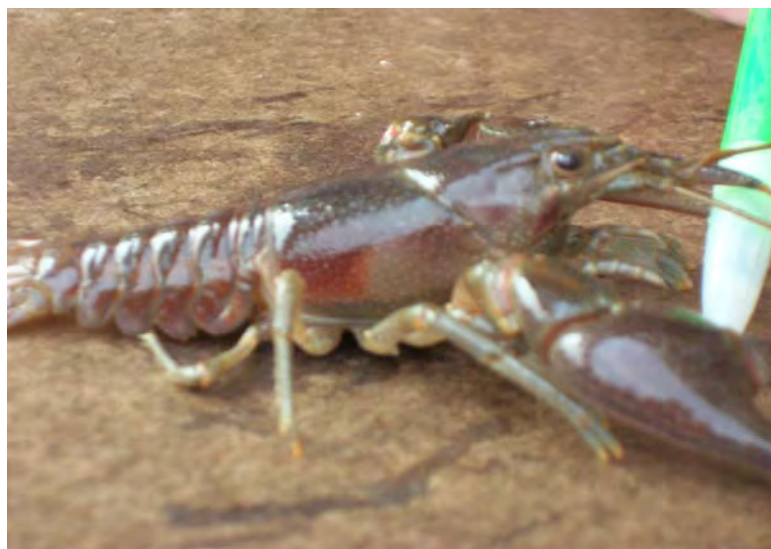
Figure 8.4. A male rusty crayfish captured in Kish Creek. Note the characteristic red blotch on the sides and the red tail. These crayfish also have smooth, blue-tinted claws. The claws of crayfish native to the Susquehanna River drainage are marked with rows of small bumps and lack a bluish tint (PA Sea Grant 2004)

During our visual assessment of the main stem of Kish Creek, we observed the presence of invasive and hybrid species. One of the invasive species, which we captured on a number of occasions, is the rusty crayfish. The rusty crayfish (Figure 8.4), native to the Ohio River drainage in Western Pennsylvania, are larger and more aggressive than species native to the Lower Kish Creek watershed and the Susquehanna River drainage and often out compete native species for the best living spaces and food sources (PA Sea Grant 2004). A single gravid female has the potential to produce thousands of offspring and populate an entire area. Native crayfish populations can suffer to the point of localized extirpation in areas where rusty crayfish become abundant (PA Sea Grant 2004). Because of their aggressive, yet elusive nature, rusty crayfish do not constitute a good source of food for smallmouth bass and large trout. This increases predation pressure on native crayfish. A local extirpation of native crayfish in Kish Creek would

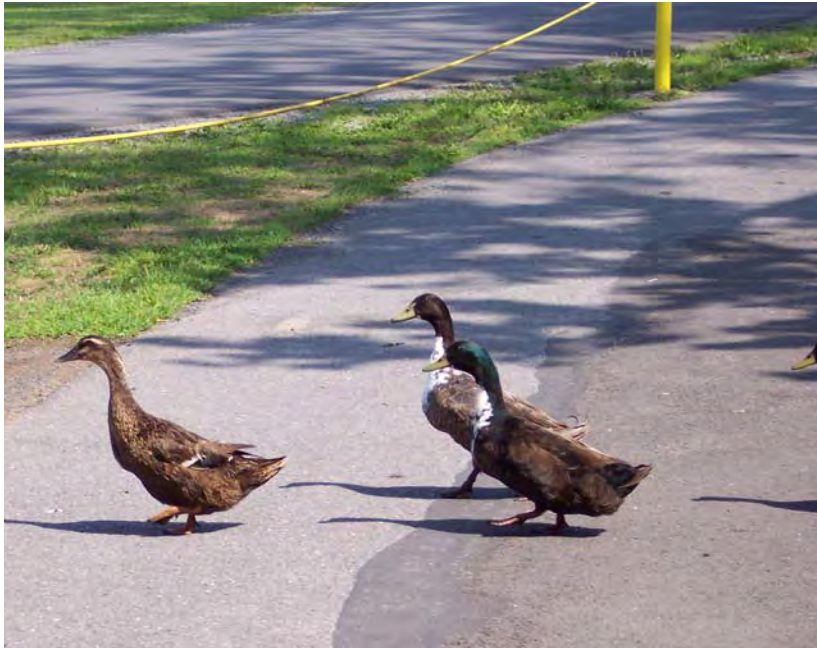
Figure 8.5. Hybrid ducks crossing the bicycle path parallel to Kish Creek in Derry Community Park. Note the iridescent green heads of the males (characteristic of mallards) and the white breast feathers (characteristic of domestic ducks).

Another non-native animal observed in the Lower Kish watershed is the domestic duck, a species originally brought over from Europe hundreds of years ago. The most harmful effect of domestic ducks on the native fauna of a region is their ability to hybridize with native species like the mallard (Figure 8.5). We observed dozens of mallard-domestic hybrids along Kish

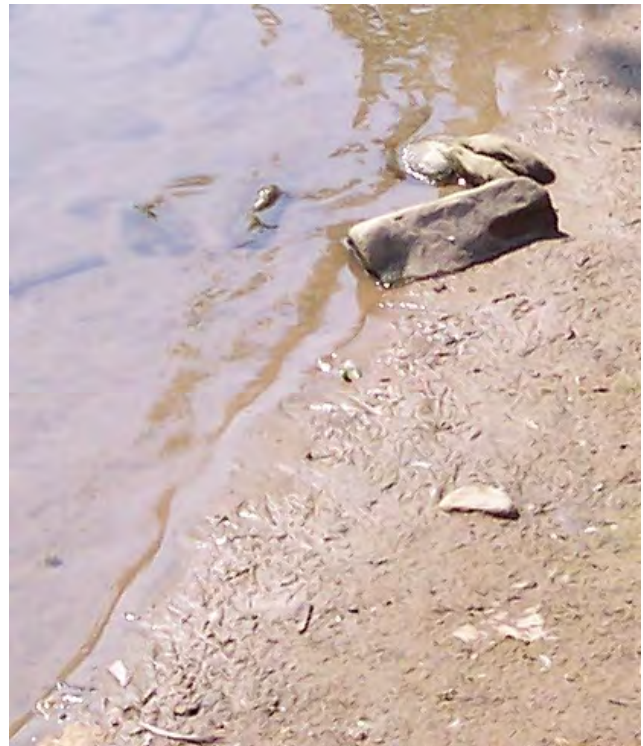
Figure 8.6. Footprints of ducks in the mud along the barren and eroded banks of Kish Creek in Derry Park.

Creek, concentrated primarily in Derry Community Park in Burnham, where they are a favorite of campers and other park visitors. The large population of ducks in the park is having a detrimental effect on both riparian and in-stream habitat. Ducks eat young shoots of vegetation growing along the bank, thus preventing them from growing. The banks of the stream in Derry Park are particularly eroded due not only to the lack of riparian vegetation, but also the constant traffic of ducks going in and out of the water (Figure 8.6). In-stream habitat is also affected by

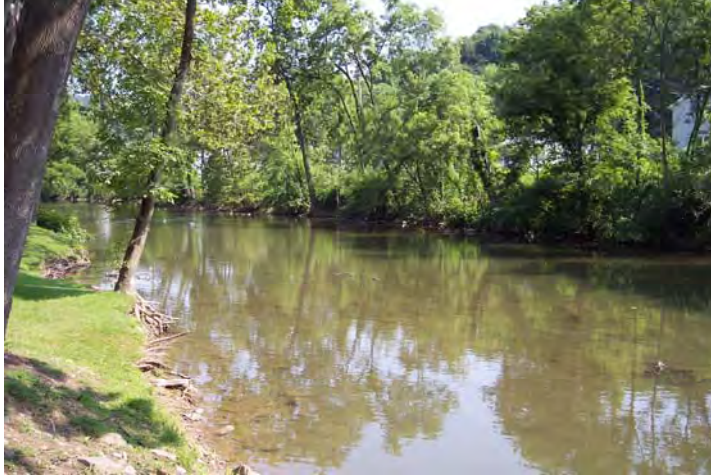
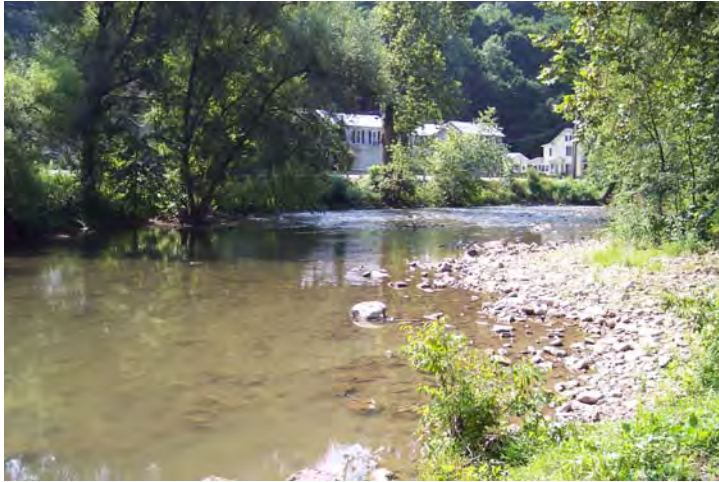
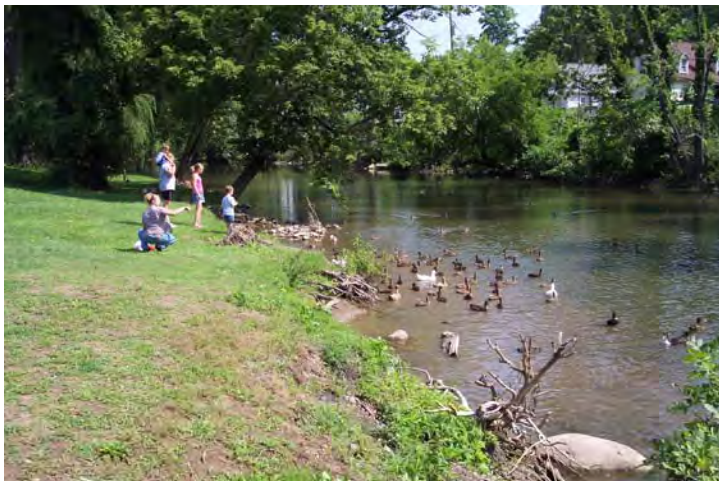
(A) **Figure 8.7.** KICR1.3 flowing alongside Derry Community Park in Burnham, PA. Note the houses and the road visible through the trees along the right bank in all three photos. (A) Long stretches of the stream are exposed to direct sunlight during daylight hours; (B) In addition to lacking tall shade trees, the KICR1.3 riparian zone is reinforced with rip-rap stones in some areas; (C) The grass is mowed right up to the stream's edge along the left bank of the stream, which contributes to problems of erosion and bank instability
